**Flood Control Project Maintenance
Levee Inspections**

Fall 2019 Levee Maintenance Deficiency Summary Report

**Flood Control Project Maintenance
Levee Inspections****LMA District Cover Sheet****Fall 2019 Levee Inspection Results****Sacramento River West Side Levee District**

Sacramento River West Side Levee District

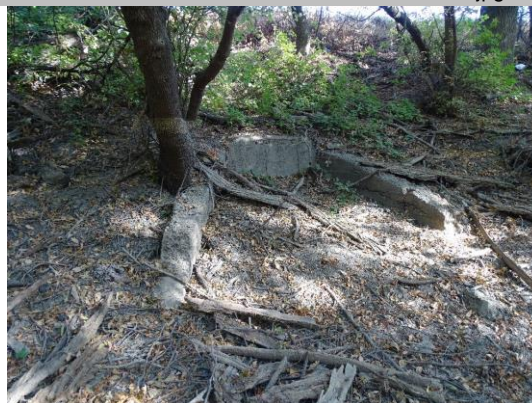
Photo 2 of 2 : UCIP_FA_2019_55794_82923.jpg

Concrete headwall and chute located at WS toe

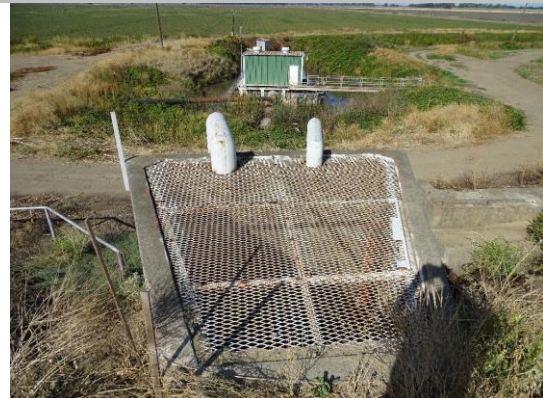
Photo 2 of 3 : UCIP_FA_2019_55802_82944.jpg

Top of concrete distribution box. Two filling pipes are coming from pump house.

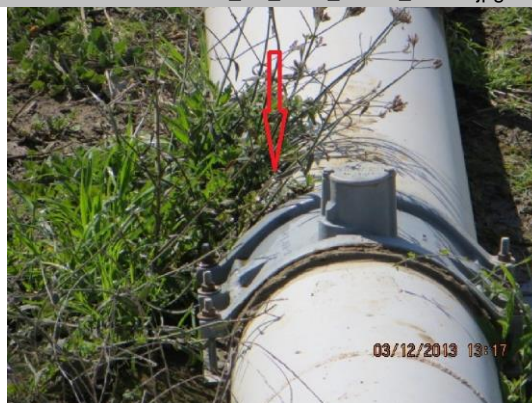
Photo 1 of 3 : UCIP_FA_2019_10129_17291.jpg

Minor leak at flowmeter on WS berm.

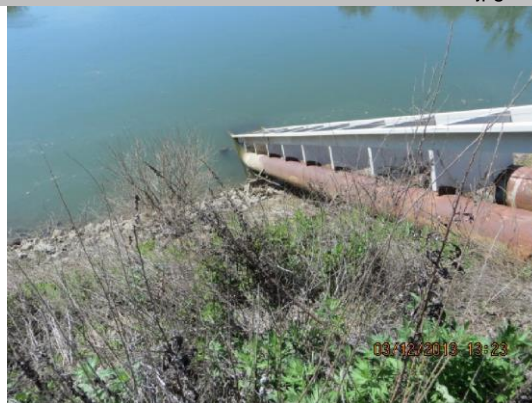
Photo 3 of 3 : UCIP_FA_2019_10129_17289.jpg

Pipe and fish screen ramp on WS.

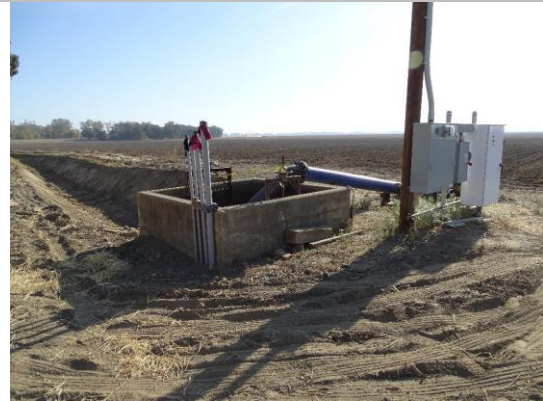
Photo 3 of 3 : UCIP_FA_2019_55828_83049.jpg

Concrete distribution box near LS toe

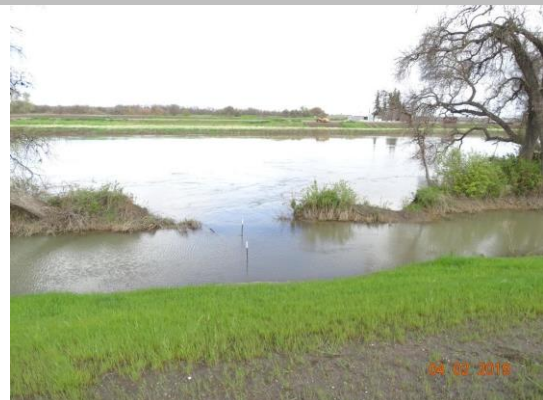
Photo 1 of 4 : FA_2019_NA0016_435_112_20190829_00043.jpg

View of erosion on the waterside berm. Spring 2019.

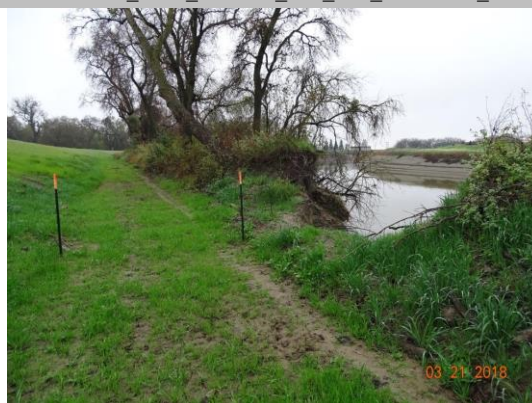
Photo 4 of 4 : FA_2019_NA0016_435_112_20190829_00046.jpg

Additional view of the berm. Spring 2018.

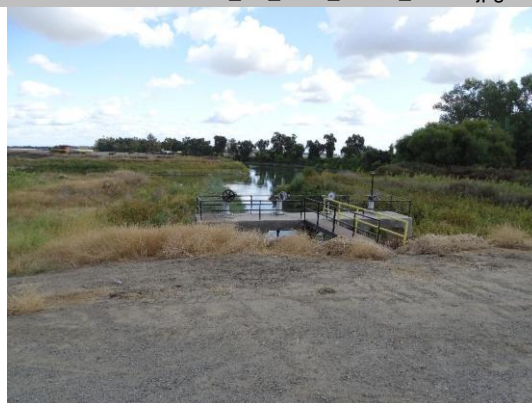
Photo 2 of 3 : UCIP_FA_2019_55837_83075.jpg

Walkway to slide gate actuators on WS shoulder

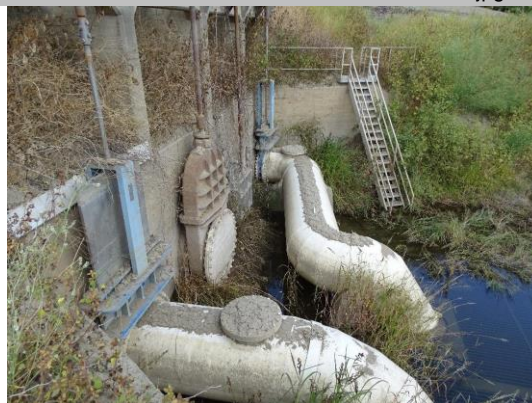
Photo 2 of 3 : UCIP_FA_2019_55838_83078.jpg

Pipes and slide gates at outlet onWS

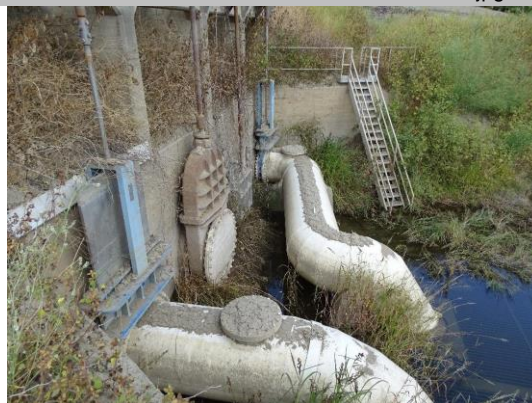
Photo 2 of 3 : UCIP_FA_2019_55839_83080.jpg

Pipes and slide gates at outlet on WS

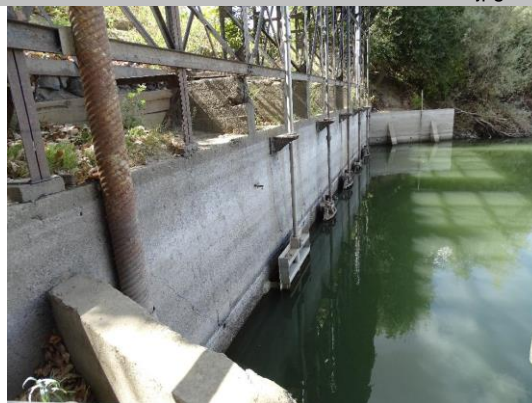
Photo 2 of 3 : UCIP_FA_2019_55842_83097.jpg

Slide gates at concrete headwall at river

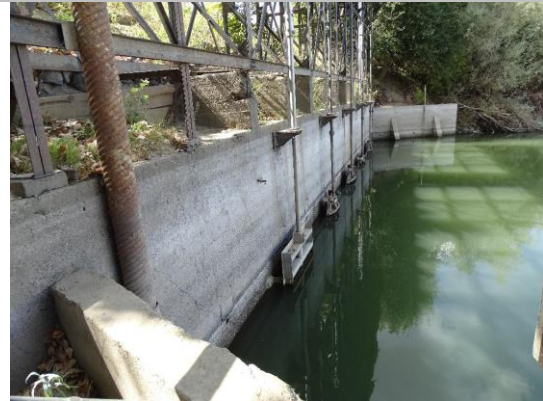
Photo 2 of 3 : UCIP_FA_2019_55845_83106.jpg

Slide gates at concrete headwall at river

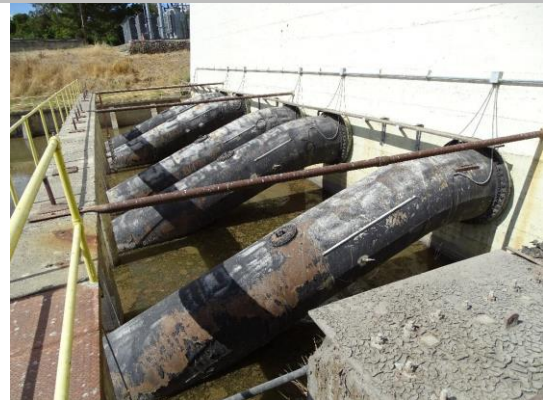
Photo 3 of 3 : UCIP_FA_2019_55845_83107.jpg

Pipes at entrance to pumping plant building on LS toe

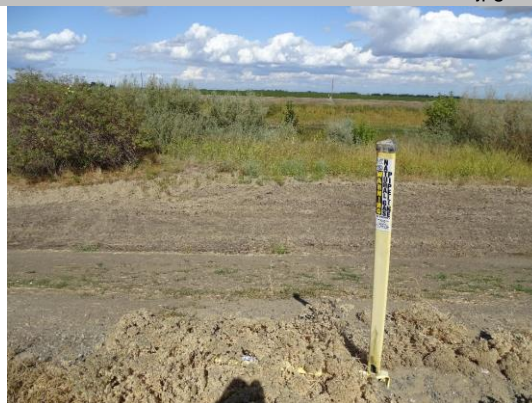
Photo 2 of 3 : UCIP_FA_2019_55882_83118.jpg

Gas line marker on WS. One at WS shoulder and another off levee toe.

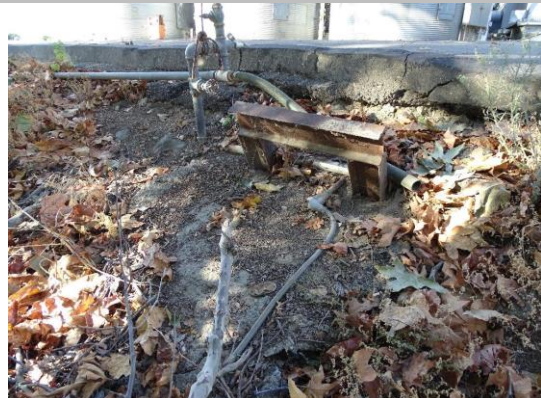
Photo 2 of 3 : UCIP_FA_2019_55894_83144.jpg

Electrical conduit at former pipe support on WS shoulder

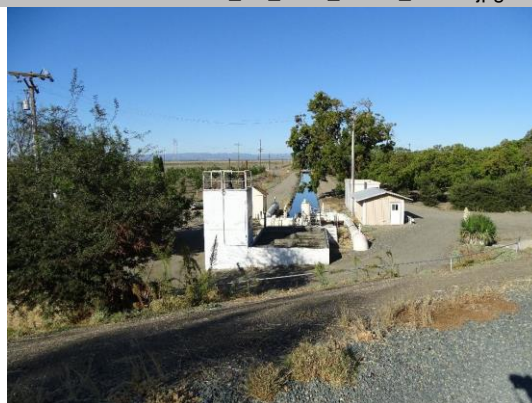
Photo 1 of 3 : UCIP_FA_2019_55896_83154.jpg

Lift station on LS at levee toe

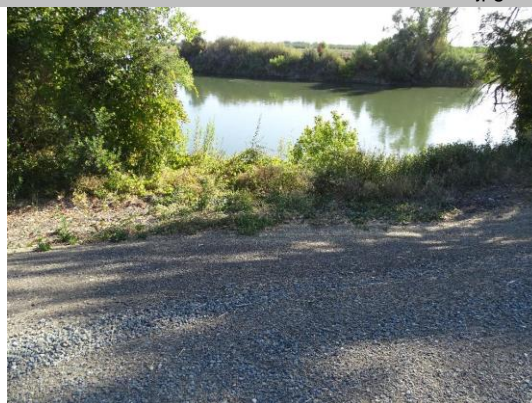
Photo 2 of 3 : UCIP_FA_2019_55896_83155.jpg

View of WS looking from levee crown

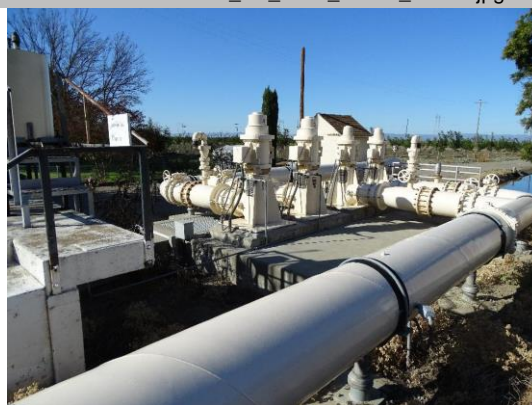
Photo 3 of 3 : UCIP_FA_2019_55896_83156.jpg

Pumps in irrigation canal on LS

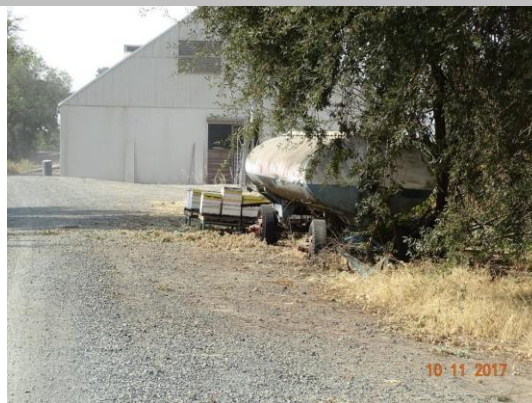
Photo 1 of 2 : FA_2019_NA0016_435_26_20190829_00005.jpg

View of equipment and beehives. Fall 2017.

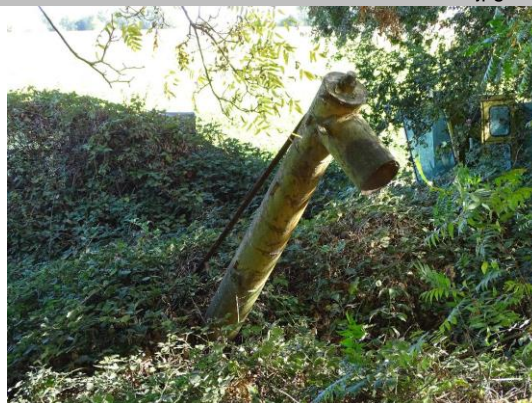
Photo 1 of 1 : UCIP_FA_2019_55903_83157.jpg

Residuals of a smaller diameter pipe

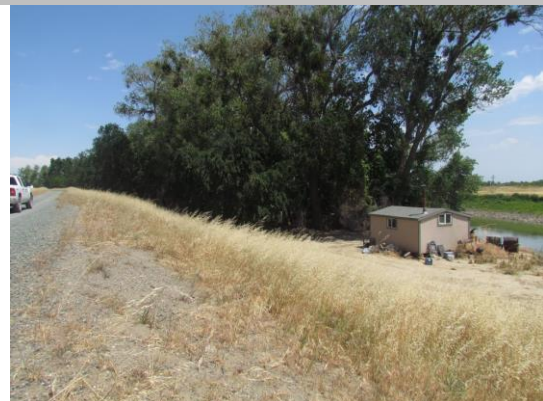
Photo 1 of 1 : FA_2019_NA0016_435_96_20190829_00034.jpg

View of the building on the waterward side of the levee looking upstream. Spring 2015.

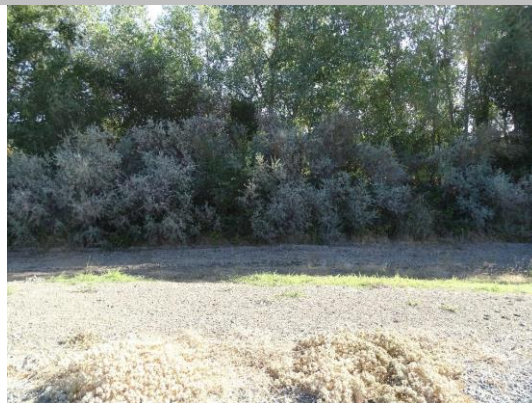
Photo 2 of 3 : UCIP_FA_2019_55904_83159.jpg

View of WS looking from levee crown. Gate valve wasn't found.

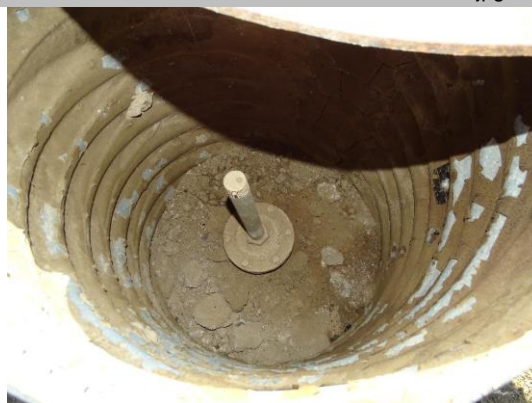
Photo 3 of 3 : UCIP_FA_2019_55904_83160.jpg

Siphon breaker inside of CMP riser on LS slope

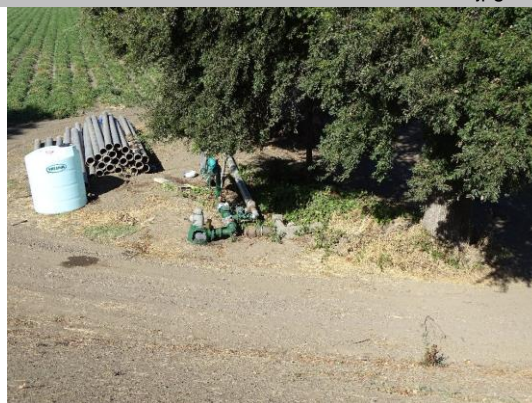
Photo 1 of 3 : UCIP_FA_2019_55905_83163.jpg

A well and concrete box on LS don't belong to this crossing

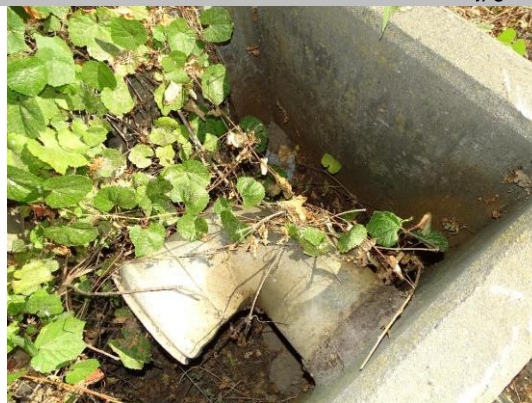
Photo 3 of 3 : UCIP_FA_2019_55905_83165.jpg

View inside of concrete box on LS

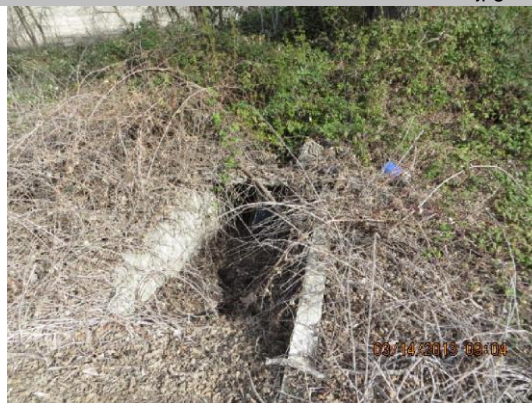
Photo 3 of 3 : UCIP_FA_2019_55910_17489.jpg

Concrete box on LS toe.

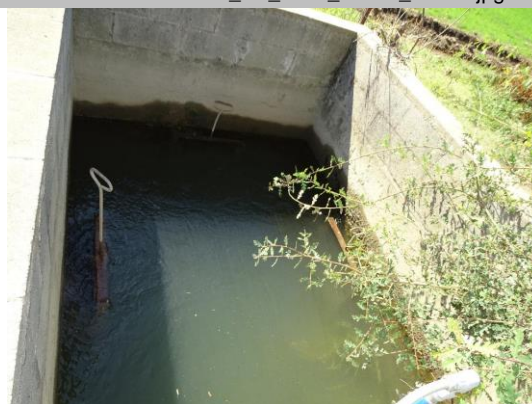
Photo 3 of 3 : UCIP_FA_2019_55914_83196.jpg

7-foot by 9-foot distribution box at LS toe

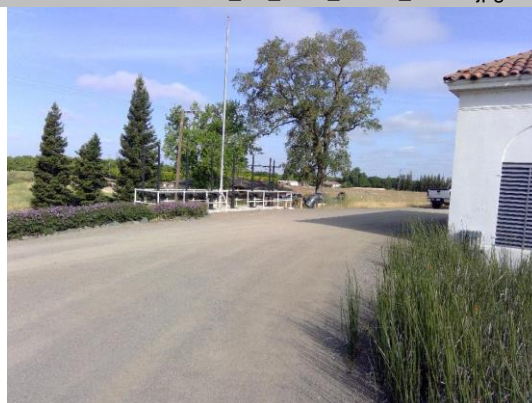
Photo 2 of 3 : UCIP_FA_2019_53968_79171.jpg

View of slide gate on LS shoulder. Six pipes are crossing levee.

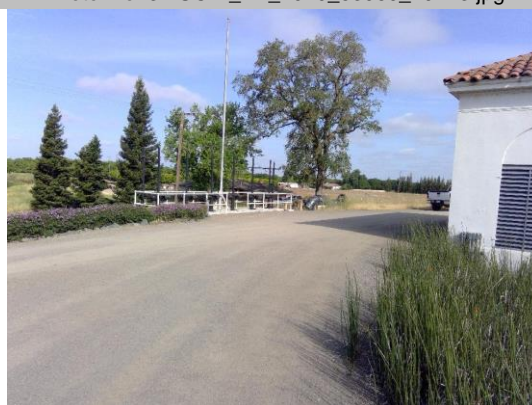
Photo 2 of 3 : UCIP_FA_2019_53969_79173.jpg

View of slide gate on LS shoulder. Six pipes are crossing levee.

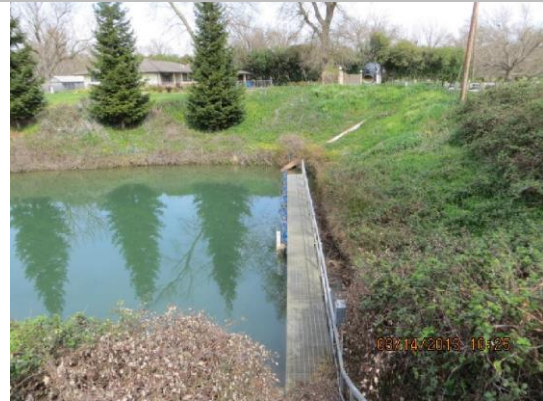
Photo 3 of 3 : UCIP_FA_2019_53969_17514.jpg

Walkway and gates along LS toe.

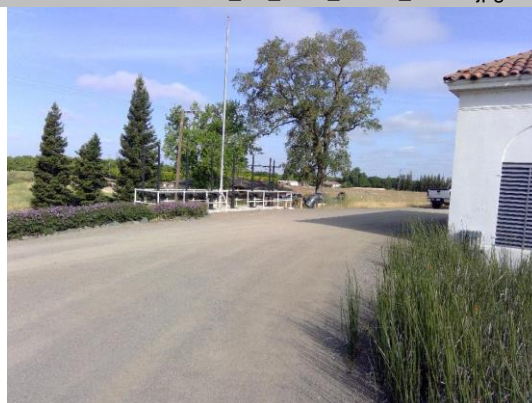
Photo 2 of 3 : UCIP_FA_2019_53970_79175.jpg

View of slide gate on LS shoulder. Six pipes are crossing levee.

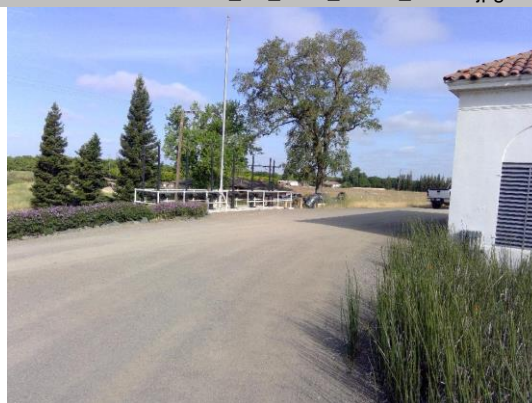
Photo 2 of 3 : UCIP_FA_2019_53971_79177.jpg

View of slide gate on LS shoulder. Six pipes are crossing levee.

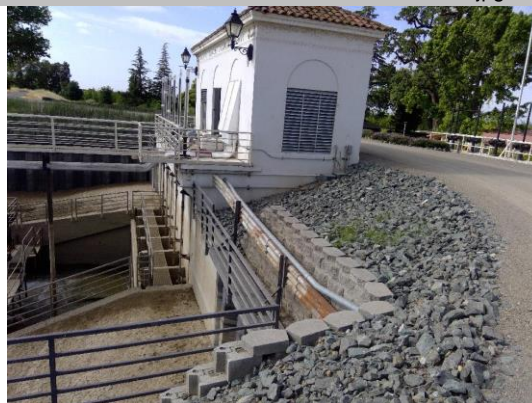
Photo 2 of 3 : UCIP_FA_2019_53974_79184.jpg

Four conduits crossing the levee. View of WS slope

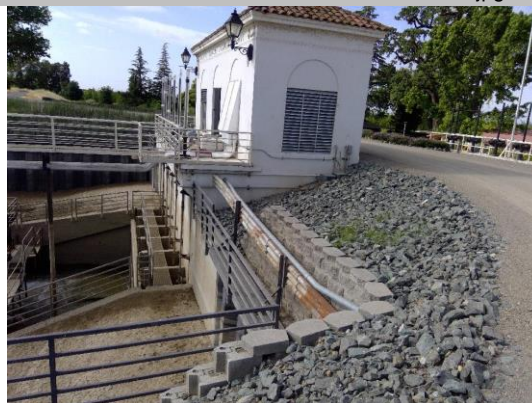
Photo 2 of 3 : UCIP_FA_2019_53976_79192.jpg

Four conduits crossing the levee. View of WS slope

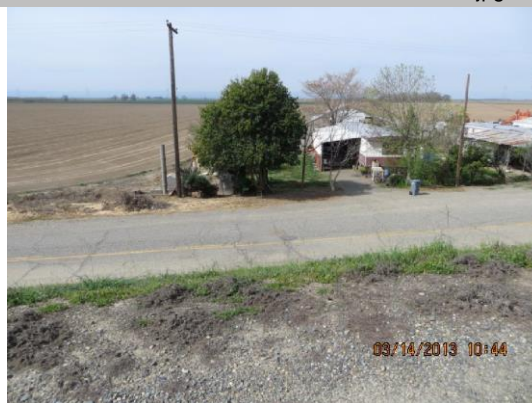
Photo 1 of 3 : UCIP_FA_2019_53977_17532.jpg

72-inch CMP riser on LS toe under JP next to tree.

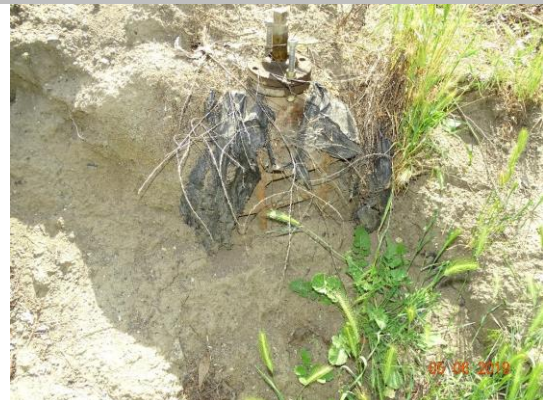
Photo 2 of 3 : UCIP_FA_2019_53982_79210.jpg

Gate valve silted at LS toe. Missing handwheel

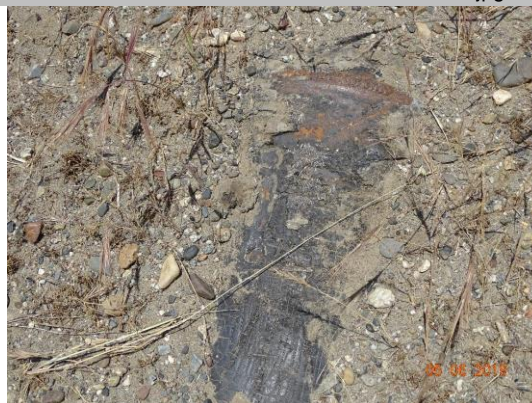
Photo 2 of 3 : UCIP_FA_2019_54146_79726.jpg

Portion of pipe is visible on LS slope

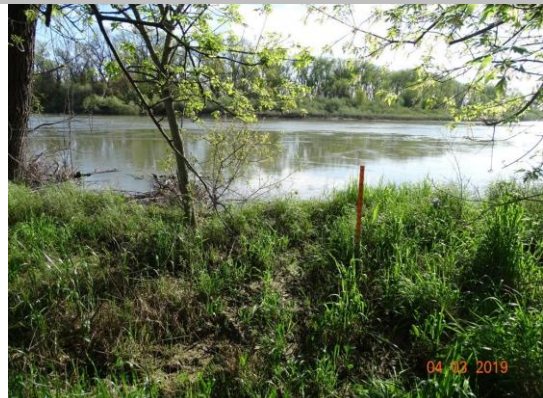
Photo 4 of 5 : FA_2019_NA0016_435_114_20190829_00051.jpg

View of the upstream stake on the waterside berm. Spring 2019.

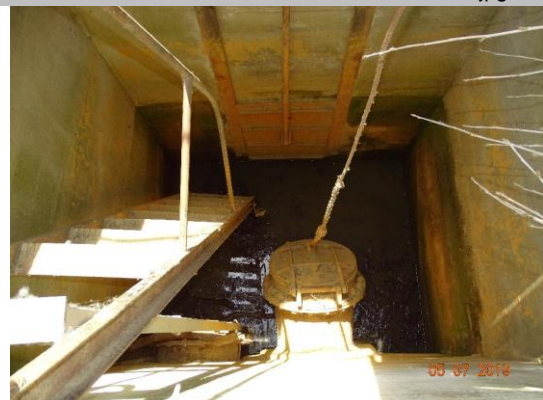
Photo 2 of 3 : UCIP_FA_2019_54173_79801.jpg

Slide gate and flap gates in Concretesurge box on WS toe

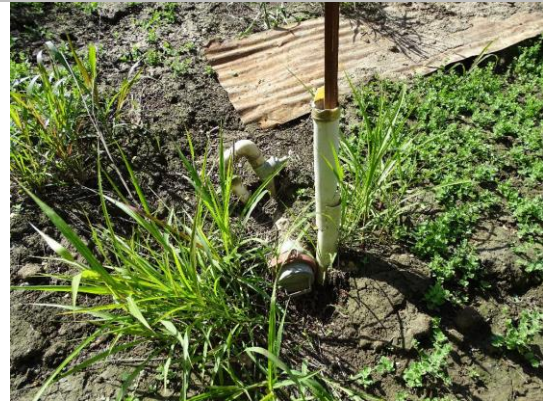
Photo 3 of 3 : UCIP_FA_2019_54225_79945.jpg

Capped pipe at WS toe

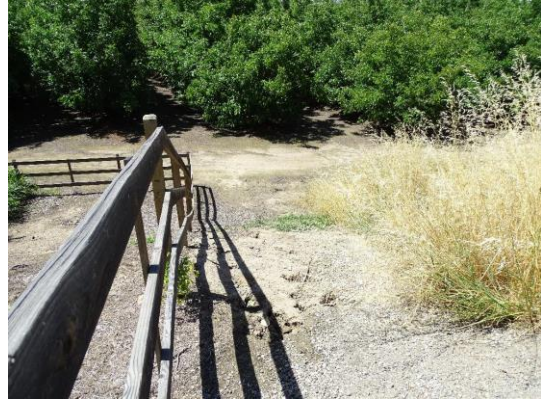
Photo 2 of 3 : UCIP_FA_2019_54230_79963.jpg

View of LS slope where concrete standpipe was located

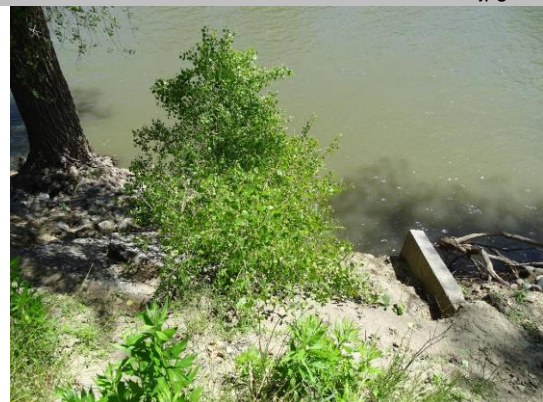
Photo 2 of 3 : UCIP_FA_2019_54231_79965.jpg

Concrete pumphouse debris on WS berm

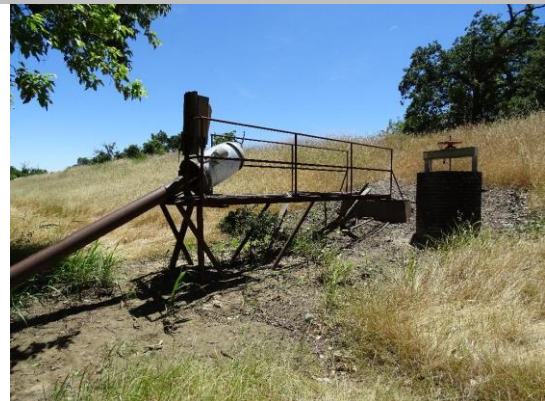
Photo 3 of 3 : UCIP_FA_2019_54245_79995.jpg

Pump with disrupted timber walkway and slide gate inside of CMP riser on WS berm
